Old 'Jewish' Shop

Umut Almaç, Mustafa Akçaöz

District of Marmara, Merkez Neighbourhood	Construction period/date: 19 th century
	Current status: The western space on Lot 851 is abandoned. The eastern space on Lot 852 functions as an internet café
GPS: 40°35'10.9"N 27°33'19.8"E	Ownership status: Private ownership
Registration date and number: GEEAYK 20.12.1975 - 8791, TKTVYK 27.02.1987 - 3045, Bursa KTVKBK 15.01.1996 - 4904

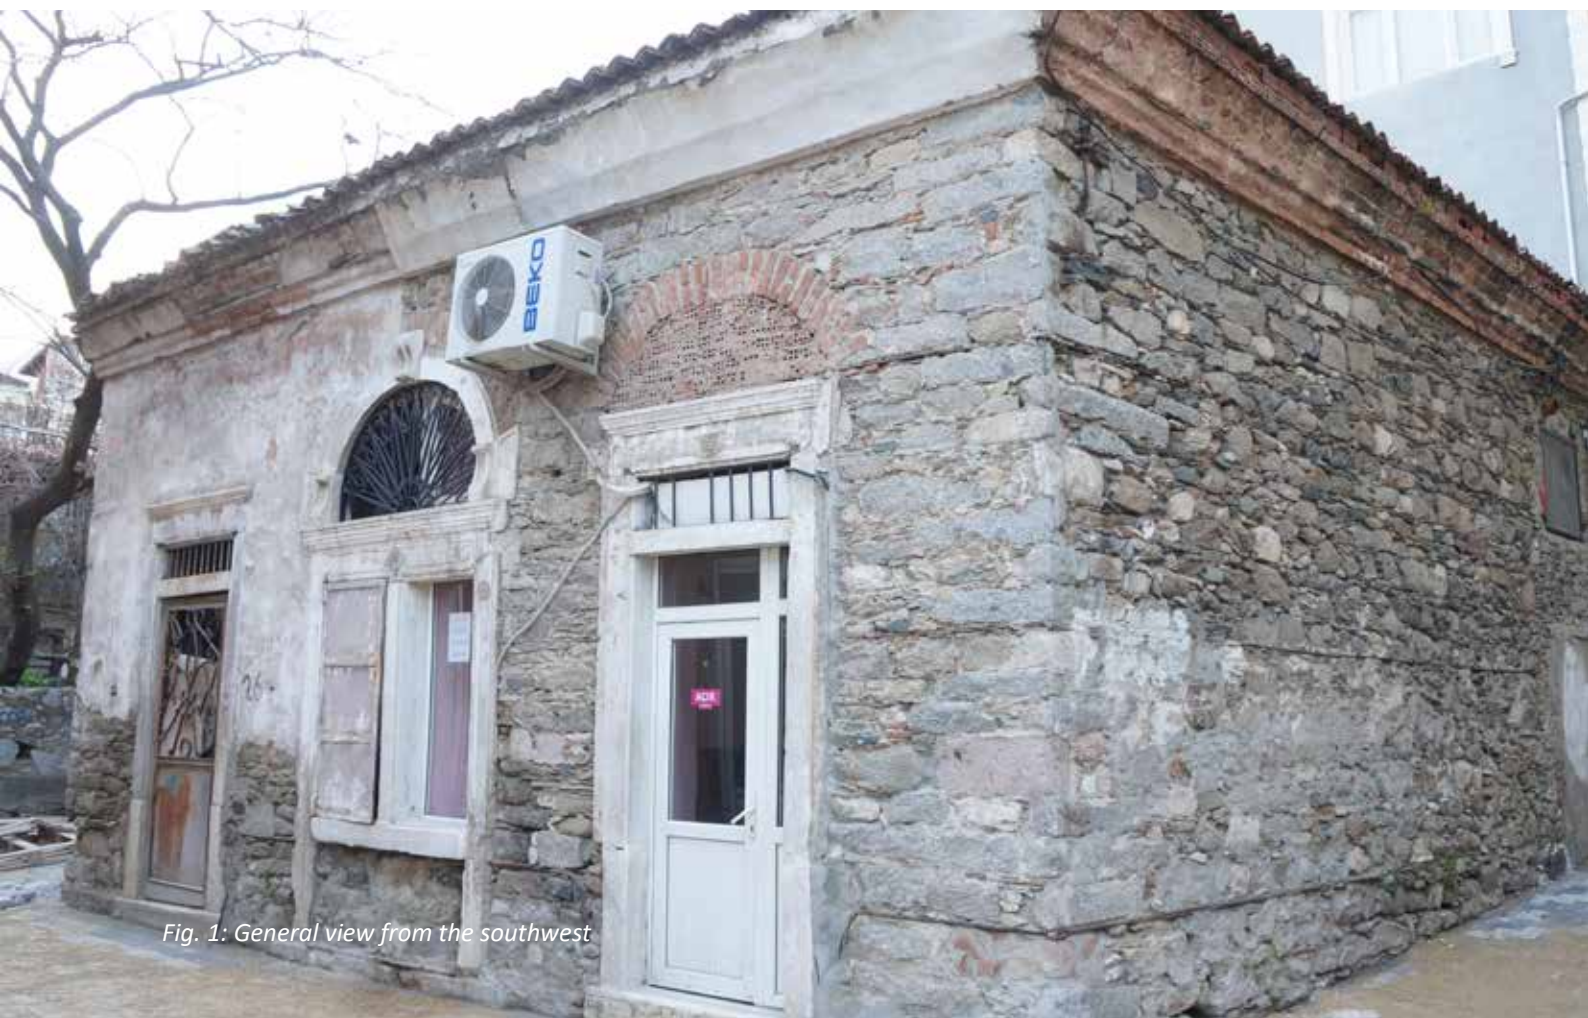
Fig. 1: General view from the southwest

This commercial building is a single-storey structure built in stone masonry (Fig. 1). The plan organization and the interior features indicate that the building was designed as a commercial structure. The building has a total floor area of 100 m² and consists of two symmetrical spaces. These are separated by a wall in the north-south direction and each have a rectangular plan organization (interior space: 4.0x9.4 m). Both spaces have a 4-m-deep, timber mezzanine floor in the north, which is accessed via a timber staircase attached to the partition wall.

The southern façade of the building, which faces Şehit Ömer Street, has openings providing access to both commercial spaces (Fig. 1). A multi-storey, reinforced concrete building is attached to the northern structure. The eastern and western façades were originally blind, i.e. there were not any doors or windows; the existing openings probably result from later interventions (Fig. 2). The southern façade, which is approximately 9 m wide, has a symmetrical arrangement; the arched opening in the centre is flanked by a doorway with a stone lintel on either side, providing access to the commercial spaces. The extant plastered sections on the façade indicate that it was originally plastered. The openings are highlighted by a slight protrusion of profiled lintels and jambs from the plastered wall surface. The arched opening in the middle is left open above the level of the springing line to benefit from natural light. An iron lattice with radial geometry is placed on this opening. A corbelled eave runs along all the façades on the top level.

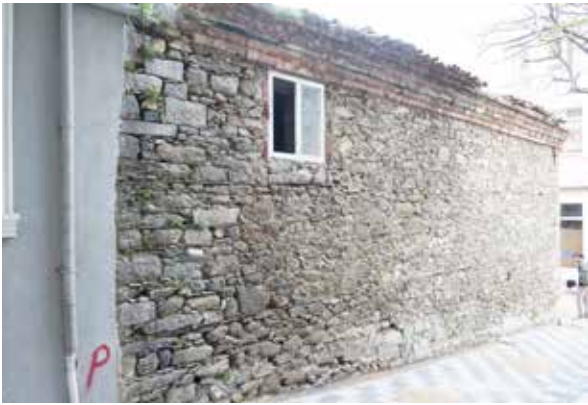
The main walls of the building are rubble masonry with a thickness of 60-70 cm. The partition wall separating the two commercial spaces is of brick masonry. Stones of the main walls do not have a regular course or horizontal levelling, and they do not lap upon one another (Figs. 1-2). Pieces of brick and tile pieces are occasionally inserted between the stones. The most striking details on the façades are the original iron elements seen in the masonry walls, which are usually used to consolidate the irregular rubble walls (Fig. 3). It is plausible that the principles and details of these iron elements are very similar to the timber bands seen in traditional masonry structures. The flat iron bars (thickness 9-10 mm, width 45 mm) are used at different levels of the masonry wall as a continuous band of two parallel rows. The vertical distance between these bands is approximately 125 cm. The iron bars used along the thickness of the walls are connected to each other via smaller iron elements (thickness 5 mm, width 45 mm) with the help of rivets. Attention has been paid to guarantee the continuity of this system that frames the structure; flat iron bars perpendicular to each other at the corners of the wall are connected.

Fig. 2: Western façade

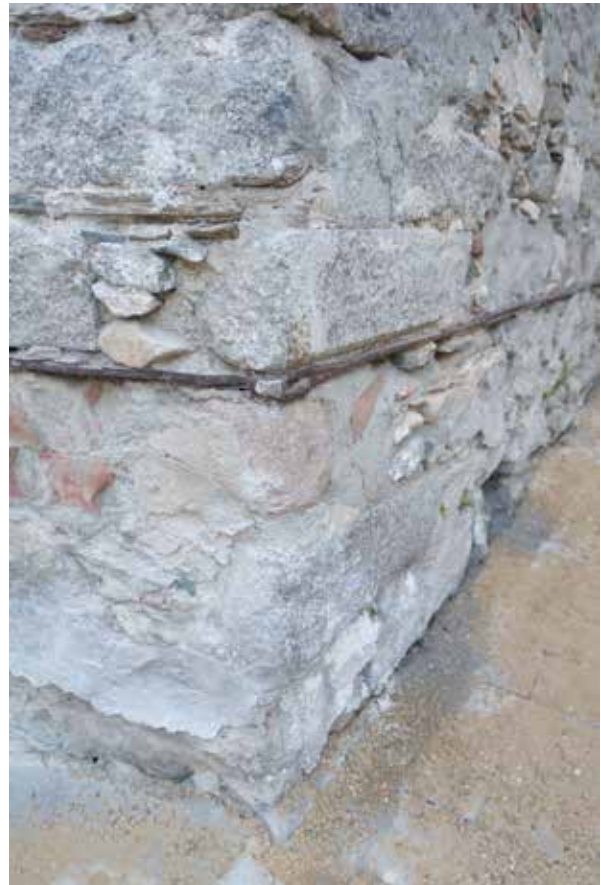
There are structural cracks in the main walls, extending from the floor to the eaves. The

Fig. 3: Detail of masonry and iron bands

connection points of iron bands are severely damaged, particularly at the corners.

The structural cracks in the masonry walls should be inspected carefully and a civil engineer experienced in the restoration of historic buildings should be consulted during the preparation of the conservation project. While the existing damage will not cause a complete collapse of the building in the near future, they can intensify in the case of a possible earthquake.

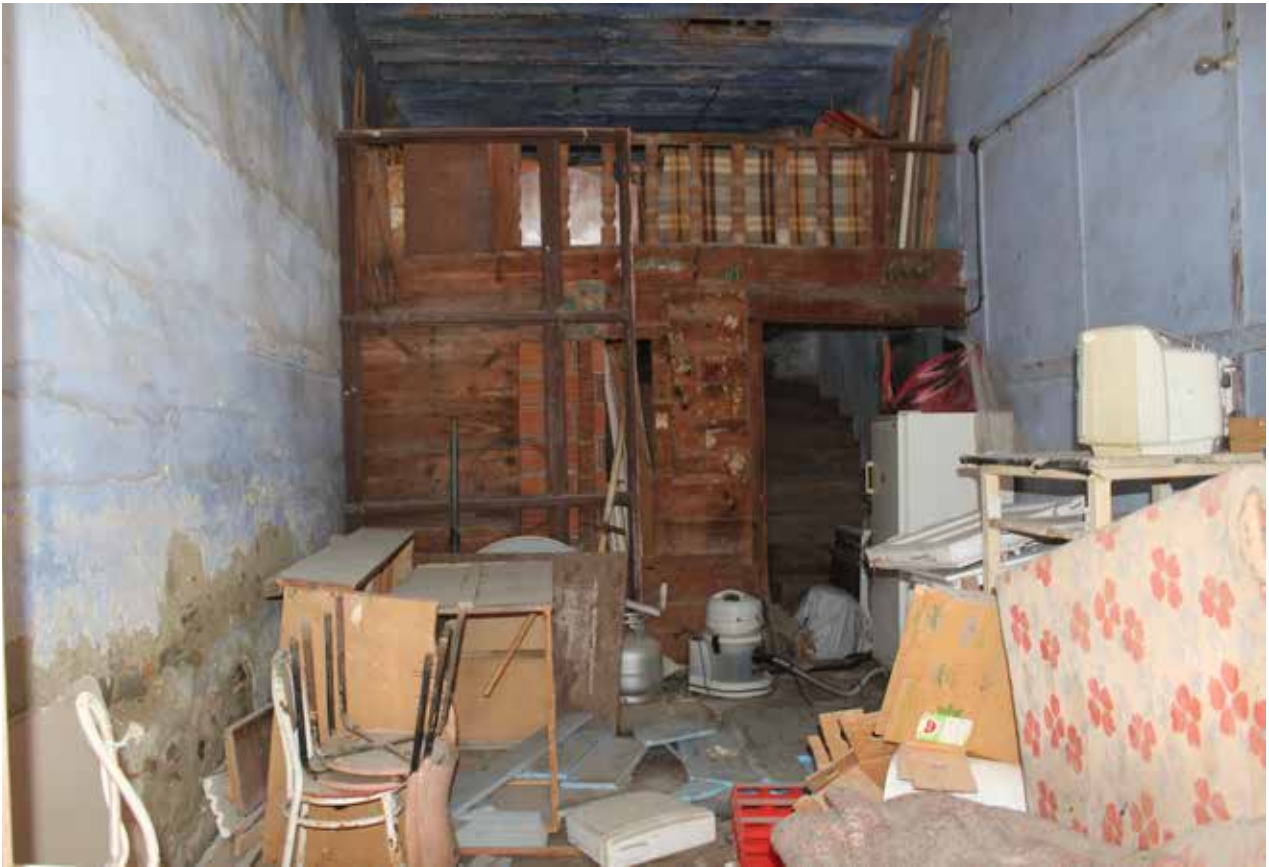
The interior spaces have a ceiling height of approximately 4.5 m and are covered by jack arches (Fig. 4). The steel I-beams of the jack arches (flange width 5 cm, web height about 16 cm) are used on the east-west axis (short edge) and connected to wall plates in the masonry wall. The hipped roof with over-and-under tiles lies on top of the jack arches. The floor by the entranceway is paved with square, terrazzo tiles (Fig. 5).

The roof of the building is in poor condition. Since rainwater penetrates the structure, corrosion issues were attested in the I-beams of the jack vaults.

Fig. 4: General view of the interior

an architectural conservation project should be prepared with a commercial function that will not compromise the building's authenticity. Otherwise, the building is doomed to collapse in the near future. The roof needs to be maintained urgently, until a conservation project can be prepared.
