Old 'Jewish' Shop

Umut Almaç, Mustafa Akçaöz

District of Marmara, Merkez Neighbourhood	Construction period/date: 19 th century
	Current status: The western space on Lot 851 is abandoned. The eastern space on Lot 852 functions as an internet café
GPS: 40°35'10.9"N 27°33'19.8"E	Ownership status: Private ownership
Registration date and number: GEEAYK 20.12.1975 - 8791, TKTVYK 27.02.1987 - 3045, Bursa KTVKBK 15.01.1996 - 4904

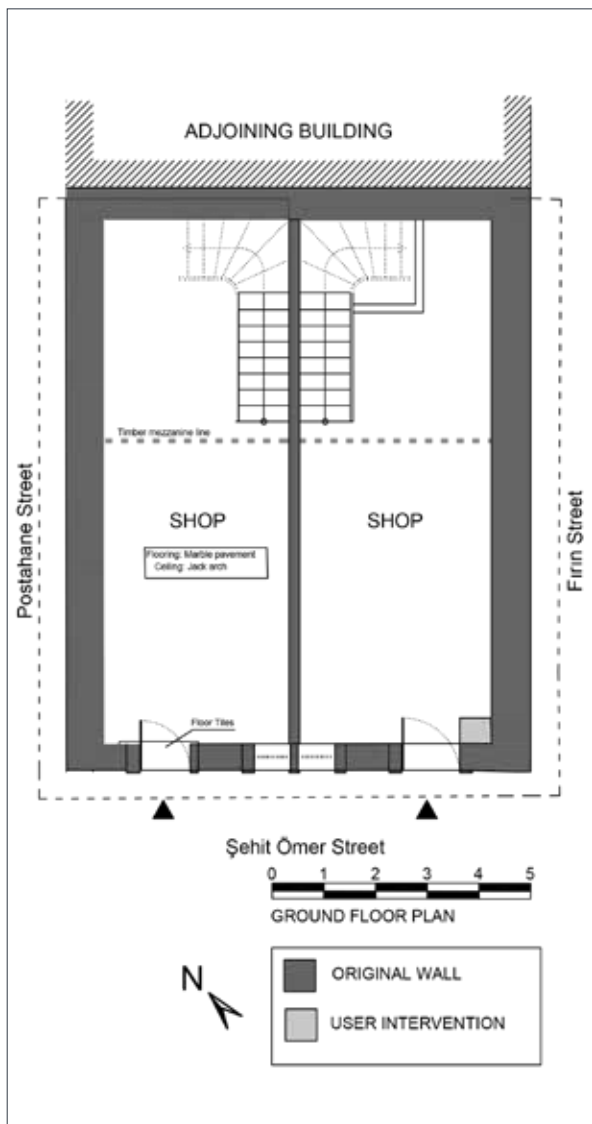
The southern façade of the building, which faces Şehit Ömer Street, has openings providing access to both commercial spaces (Fig. 1). A multi-storey, reinforced concrete building is attached to the northern structure. The eastern and western façades were originally blind, i.e. there were not any doors or windows; the existing openings probably result from later interventions (Fig. 2). The southern façade, which is approximately 9 m wide, has a symmetrical arrangement; the arched opening in the centre is flanked by a doorway with a stone lintel on either side, providing access to the commercial spaces. The extant plastered sections on the façade indicate that it was originally plastered. The openings are highlighted by a slight protrusion of profiled lintels and jambs from the plastered wall surface. The arched opening in the middle is left open above the level of the springing line to benefit from natural light. An iron lattice with radial geometry is placed on this opening. A corbelled eave runs along all the façades on the top level.
