Syriac Architectural Heritage at Risk in

Tur'Abdin

©KMKD January 2022

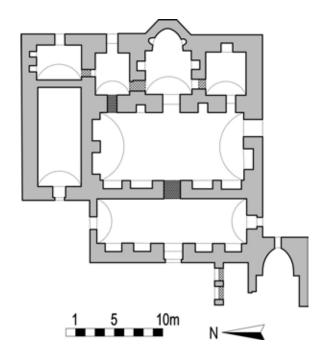
Mundell Mango mentions two sources referring to this church in the 19th century (1982, 48). In his chronicle, Ainsworth states that "they passed by a large grain warehouse called 'Anbar Dara' in front of Dara". Ainsworth's impressions cannot be associated with the church that is even obvious today due to its architectural characteristics, but should be about a nearby building (Ainsworth, 1842, 117). This structure is probably at the site of the windmills, to which Whitby was referring, next to the riverbed in the village of Ambar (Whitby, 1986, 749). Sachau mentions the village of Ambar on a hill west of the river Dara and remembering a church among the ruins (Sachau, 1883, 394). The impressions of Sachau indicate that the church was not in use in the second half of the 19th century and was neglected. The drawing of the church by Mundell Mango, reproduced here, continues to be the best documentation of the building (Mundell Mango, 1982).

The building complex was constructed in masonry technique using fine-cut stone blocks, almost all of the same size. The walls have generally double stone (without infill) thickness, and only the vaults are jointed. The wall technique and the wear condition of the stones indicate that the adjacent buildings using the walls of each other were constructed simultaneously. The entrance to the main church, the largest mass of the building complex, is from the narthex through a gate located at the central axis of its west wall. The apse in the east is semi-circular from the interior and half-hexagonal from the exterior. The use of the polygonal apse form in the Cathedral of Dara suggests that the apse of

There are four wide niches with semi-circular arches in the west wall. Two niches in the east, north, and south walls and four niches in the west wall of the naos bear similarities with the niches in the narthex in terms of their size and form. Although these niches were evaluated as tomb niches in the past (Mundell Mango, 1982, 52), there are not any earlier period tombs in the main spaces of the churches when other monastery churches are considered. These niches have deteriorated and are used as mangers at present. The naos is illuminated by three arched windows on its south wall and the tilted windowsills provide more intense daylight.

The section involving the apse on the very east is accessible by three doors with plain and carved lintels in the east wall of the narthex. This section consists of a central space with an apse, and two square planned side chambers in the north and south, which are similar in size with the central space. All three spaces are covered by barrel vaults extending in the east-west direction. There are niches in the north and south walls of the apse as well as its semi-circular east wall. Similar niches can be seen in the east and south walls of the chamber in the south. There was probably a niche in the north wall of this chamber. The existing remains are not sufficient to suggest the existence of a window in the central axis of the apse's east wall. Although there is limited information on liturgy in late antiquity in this region and the usage of the transverse space in that period, the side chamber should have served as pastophorium.

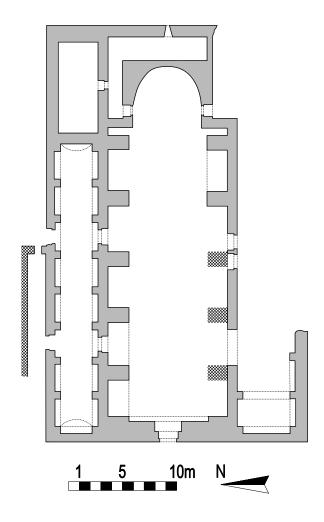
The church of Mor Sobo is larger than many other village churches in Tur Abdin region. The apse has a passage at the back in the shape of ambulatory, which is rarely seen in other churches. The piers and the arches on their top, constructed with stone and brick, are added later. They cover the architectural ornamentation in the apse, windows on the upper level and doors on the lower level. While the stones used in the apse are large cut stones, smaller rough-cut stones were used in other parts of the church. The corners are again reinforced with large cut stone blocks. While fine-cut stone is used in the piers attached to the walls in other village churches, the piers in this church were constructed with alternating rows of brick and smaller stones. The four doors with profiles opening from the narthex to the naos, are grouped in pairs. Unlike other churches, there is another narthex to the west of

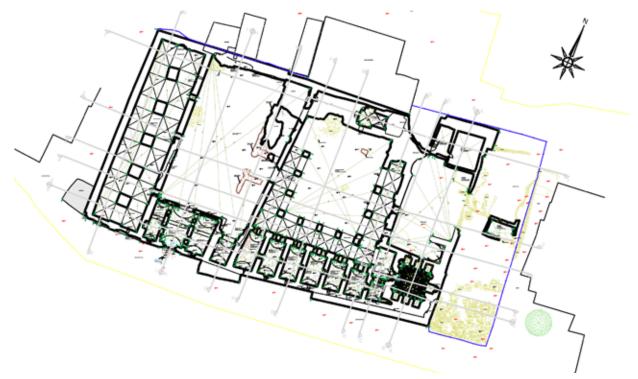
We thank to the Syriac Catholic Church Foundation for sharing this drawing with us.

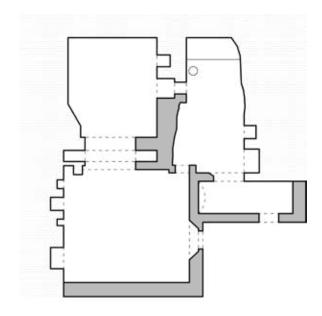
Plan of the main church of the monastery

The description below concentrates on the monastic church, with a brief overview of other buildings to follow. The monastery church lies at the east end of the lower terrace, approached from the west through a portico building and with a courtyard in front of the church. The church is a combination of masonry structure at the front with rock cut elements further back. The north side is formed by a rock-face or cliff, with rock-cut rooms running into it. The portico building has two arches on the courtyard side; two doorways on the west side. The west façade of the church is a structure of rubble masonry leading into a narthex and thence into the nave to the north and to the room for relics to the east.

The church consists of two main components, both nearly square. The nave is largely featureless, other than niches in the north wall. At the east end of the nave is a raised platform in front of the sanctuary, reached by four steps in the centre, flanked by a low wall on either side. The sanctuary wall is a solid partition with central door and four triangular apertures above. The sanctuary is also nearly square and is positioned north of the central axis of the nave, so that the north walls align, thus leaving room for a side chamber to the south of the sanctuary. To the south of the church is a room for relics,

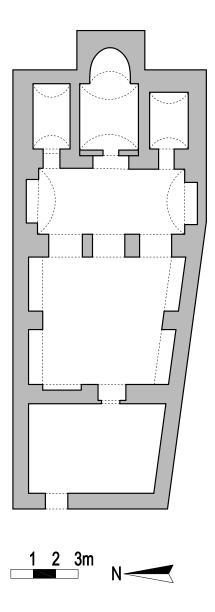
The level of the lintel today gives an idea about how much the building is filled with earth today.

A barrel vaulted transversal rectangular space, a sort of enclosed transept, stretches between the nave and the apse. Its function is not clear and such an additional space between the apse and nave is unusual for the region. Here, the geometry of the church is more regular and the oblique walls of the previous two spaces no longer distort the plan. This part is divided from the roofless space by large piers which are decorated with uncut acanthus leaves. This transitional space leads to the three partite apse. The level of the soil has risen so dramatically here that it hides much of the decorative features of the apse. We can see a winged palmette ornament and a crude vine scroll on the lintel which is now on the ground level.

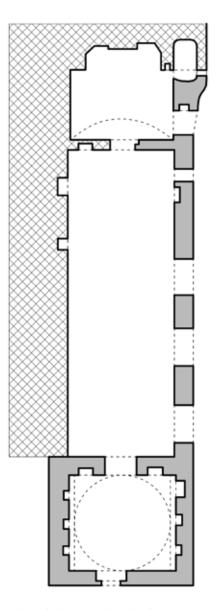
Plan of the main church of the monastery

The monastery is composed of numerous rock-cut and built structures of various sizes. These structures are spread over a wide area and leaning on a hillside (see Sinclair, 1987, 348 for a sketch showing the relationship of these spaces). The porticoes are particularly remarkable from a distance. The most striking of these spaces, which are connected to each other at different levels, is the monastery's main church (Bell-Mango, 1982, 5). The entrance of the church, which is located on the hillside, is reached by stairs from the upper level. The southern wall is supported by buttresses and there are not any prominent features on the façades. The square narthex in the west is covered by a brick dome with squinches used as transition elements. A similar but smaller dome can be observed in the Mor Awgin monastery dating to the 12th century. Therefore, the dome of the narthex can be dated to a similar period. There are eight reliquary niches with brick arches in the walls of the narthex.

The unusually long naos of the church extends on an east-west axis. Similar to other Eastern Syriac monasteries, this plan type was preferred, different than the Western Syriac monasteries. On the eastern side of the naos, there are two niches facing each other in the northern and southern walls, and these niches are believed to encompass the tombs of Mor Yuhannon and his mother (Bell-Mango, 1982, 5). The naos and apse sections are separated by a templon wall, which is partially comprised of reused materials. The pointed arches in the apse section suggest their date as earliest 12th century. It can be observed that the church has undergone numerous urgent and sloppy repairs. The brick barrel vault over the naos reveals a very rare construction technique. An almost flattened brick work at the top of the vault continues with alternating rows of bricks and rubble at lower levels.

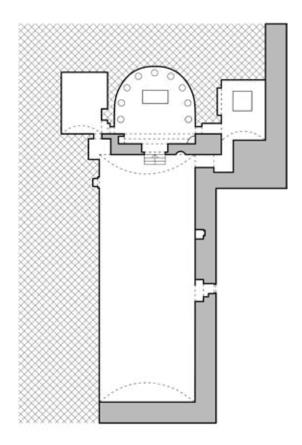
Plan of the main church of the monastery

To the east of this complex lies the main church of the monastery, which is rectangular in an east-west direction. From the exterior, the apse is covered with a quadrangular filling, concealing its semicircle. The nave is also covered with a flat roof on the outside. The whole roof has been covered with concrete, and has a date of November 1972 incised on it. The church has a later portico parallel to the nave. To the north of the portico is a narthex. It rises higher than the portico and has three rectangular windows

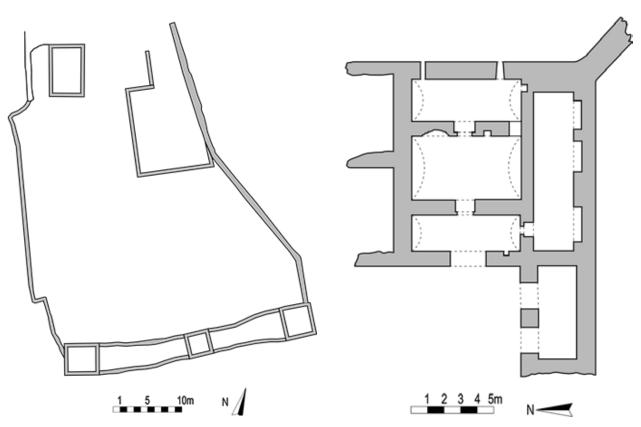
Plan of the main church of the monastery

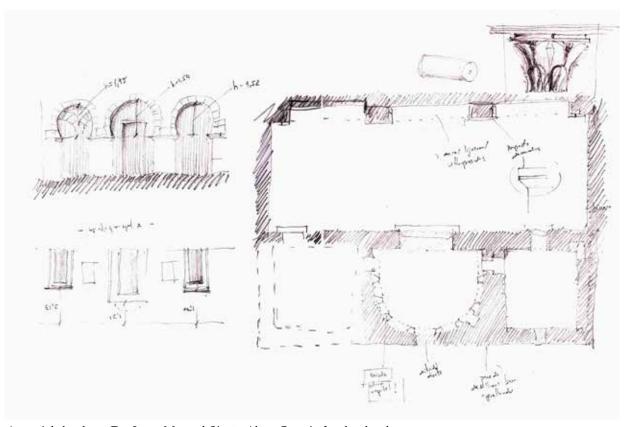
A special thanks to Dr. Jorge Manuel Simão Alves Correia for the sketch.

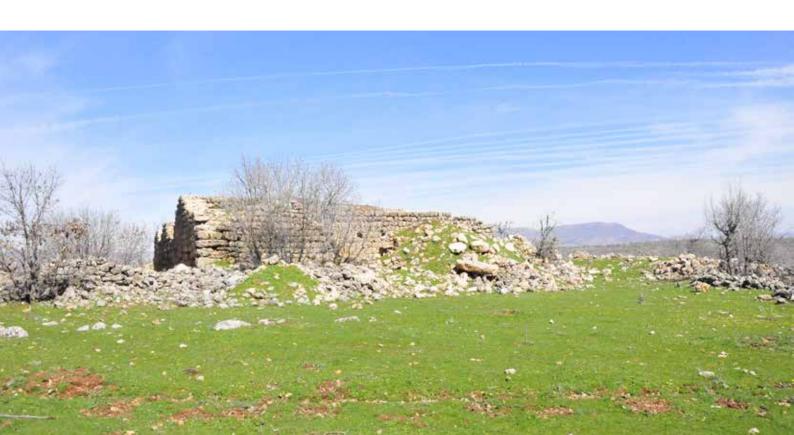
The building is constructed in rubble and rough-cut stone masonry. Rough-cut stones and large stone blocks are used in the wall joints, pillars, and piers of the arches. The main walls are approximately 100 cm thick. Lime mortar is used as binding material and plaster fragments are observed on the interior of the walls. The upper structure and the upper sections of the main walls, starting

from the springing line of the arches, have not survived. The spatial characteristics of the building indicates that the naos was covered by a barrel vault extending in the eastwest direction, and the narthex was again covered by a barrel vault extending in the same direction at a lower level. The floor of the western part of the narthex is higher than the rest. This section might have been a space separated from the narthex by a wall.

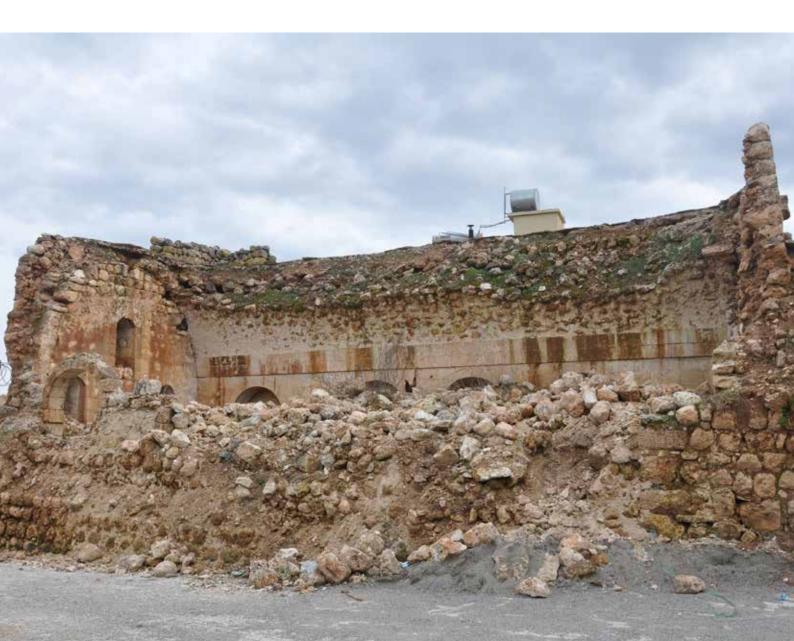
The church is located to the south of the hamlet which is 1 kilometer northwest of the village center. The northern part of its courtyard was divided due to the road opened later and resulted with the destruction of the building's north façade. There are three graves in the south of the courtyard. The building consists of three main masses, which are attached to each other from their short sides.

The mass on the west is covered by a barrel vault extending in the east-west direction. The entrance is through a rectangular door opening on its south side. There is an arched door opening, which was closed later, and an arched niche on the western wall of this space. On the upper level of the wall is a rectangular skylight near the top of the vault. To the east of the entrance in the south wall is a fireplace with a triangular pediment and a rectangular niche. There are four rectangular niches in the northern wall. This section can be a service space, such as a warehouse or kitchen. There are the remains of a door opening in the north-east façade of the space. This opening might be the entrance gate to the courtyard.

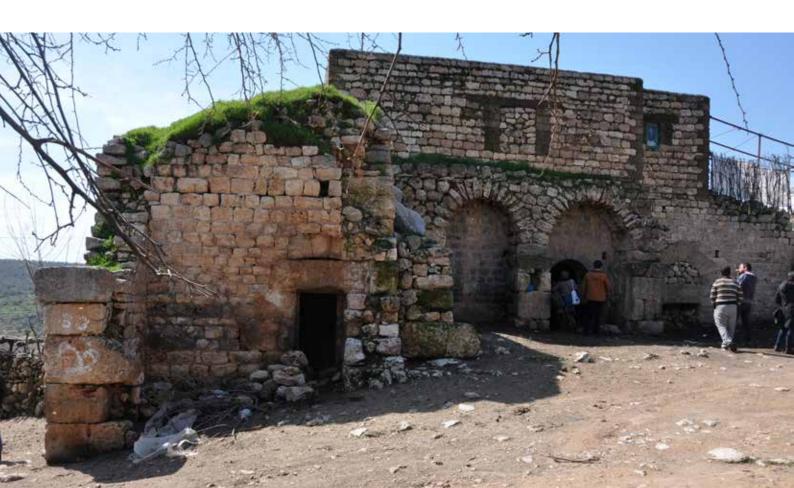
The church is a typical village church, extending on the east-west axis. Only the apse and the south wall of the single-nave naos are still standing. There are three piers and arches on their top, adjacent to the southern wall of the naos. These elements were once carrying the upper structure of the church, which is lost today. While the piers are

constructed with large cut stones, the arches are built with smaller rough-cut stones. In the south of the naos is the narthex, continuing along the naos. The narthex is covered with a barrel vault. The entrance from the narthex to the naos is through a door opening with a monolithic lintel. There is a rectangular protrusion on top of the lintel. This protrusion might be left for an inscription or an ornamentation, which was probably never completed.

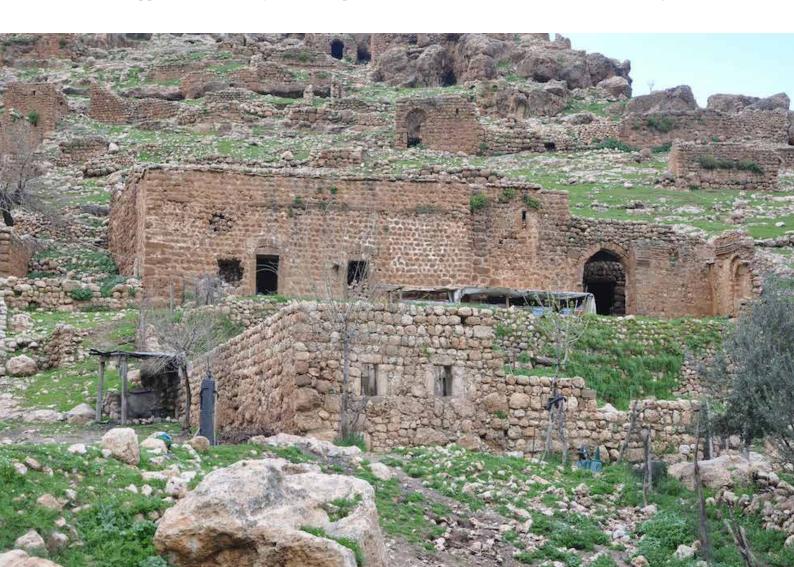
The church lies among remains of a small, isolated medieval town which consists of stone houses and ancient cave dwellings. The town stands in an enclosed, basin-like space formed by a widening of the valley cut into the escarpment. Out of the north slope rises a rock crowned by a small, ruined fortress. The town's buildings, mostly ruined, stand on the rock shelves descending from

The Church located at the foot of the hill, is a masonry structure built mainly of roughcut stone; however, its arches and columns are of fine-cut stone. The complex is rectangular on an east-west axis, with its northern façade partly embedded into the slope of the hill. There are two entrances that open into the narthex which is parallel to and south of the nave. These entrances have arches with keystones above horizontal lintels. The narthex is plastered (with bread stamps as a decoration on some walls) and covered with a barrel vault. There is a single window on its east wall, providing insufficient illumination. The only entrance from the narthex to the nave is directly opposite the western main door of the narthex.

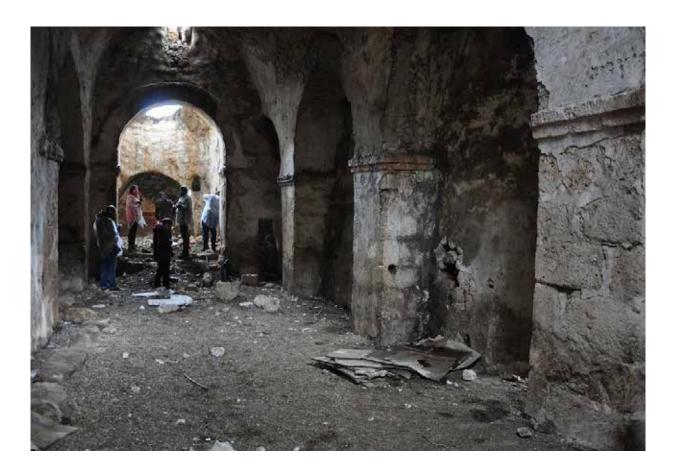
There is a passage on the south wall of the apse, which leads into a square-shaped chamber. This chamber connects to the east-ernmost end of the narthex with a door on its west. There is another passageway to this chamber, which is on the southeastern corner of the nave that first opens into a small room with a low ceiling. Terracotta tiles are visible in the central axis of the vault of this small room. This room has another door to its east, which connects to the aforementioned, square chamber.

There is another, separate rectangular space positioned at the east of the nave and narthex, in a north-west direction. This rectangular space is a later addition to the church and exiting it from its south end, one finds the remains of another structure. It can be entered from a wide arched opening on the eastern corner of the west façade of the complex and is comprised of multiple spaces of which the first two to the west are sub-divided with arches. There is a passageway roughly at the center of the west wall of this space, which allows access into the square-shaped chamber to the south of the apse.

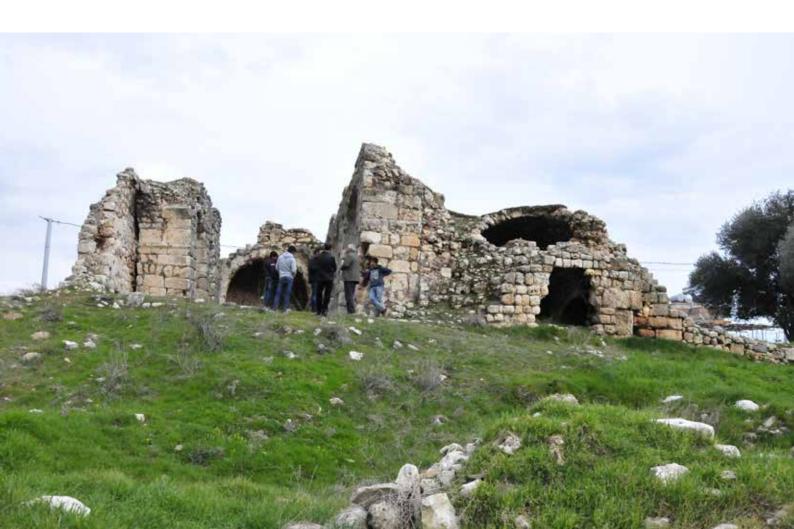
Large cut-stone blocks are used at the church's foundation level, wall corners, arched openings, piers, lintels, niches, and in certain parts of the exterior façade. Roughcut stones are used in the exterior and interior wall coursing, which get smaller towards the upper levels. While limestone is the main building material, brick was also used in the apse's dome and the superstructure

of the narthex. Plaster traces are seen on the north-eastern arch and the narthex's vault. There are rectangular door openings, connecting the naos to narthex, in the southern interior wall in-between the piers in the west and middle axis. These door openings are emphasized by curved relieving stones on their lintels. Horseshoe-shaped arches of the piers have profiled imposts at the level of the springing line.

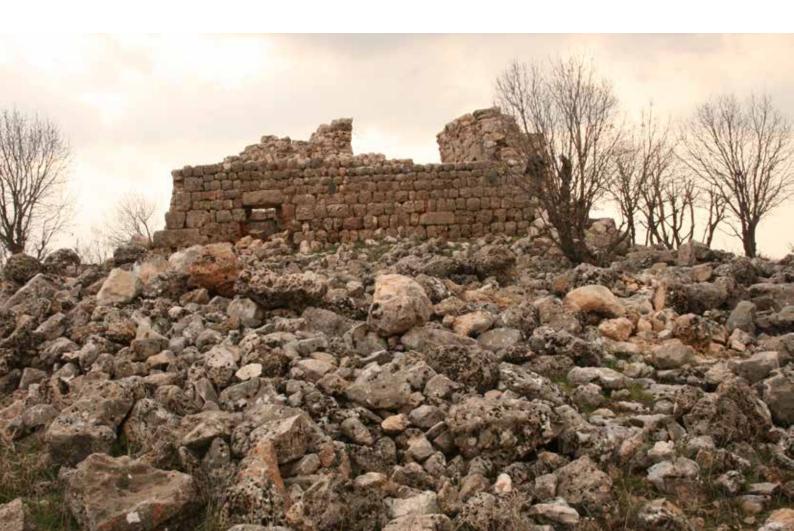
The upper structure of naos is lost. However, the inclined vault remains on the main walls reveal that the naos was covered by a

barrel vault in an east-west direction. The apse is semi-circular from the interior, and rectangular from the exterior, and it does not protrude from the façade. There is an arched opening in the north wall of the apse. The remains of walls and spaces suggest the existence of a narthex in the south of the building. The entrance is through a door opening with a flat lintel in this space. There is a rectangular niche in the northeastern wall of this space, and a door opening with a flat lintel on the north of the west wall. The inclined vault remains indicate that this room was covered by a barrel vault in north-south direction.

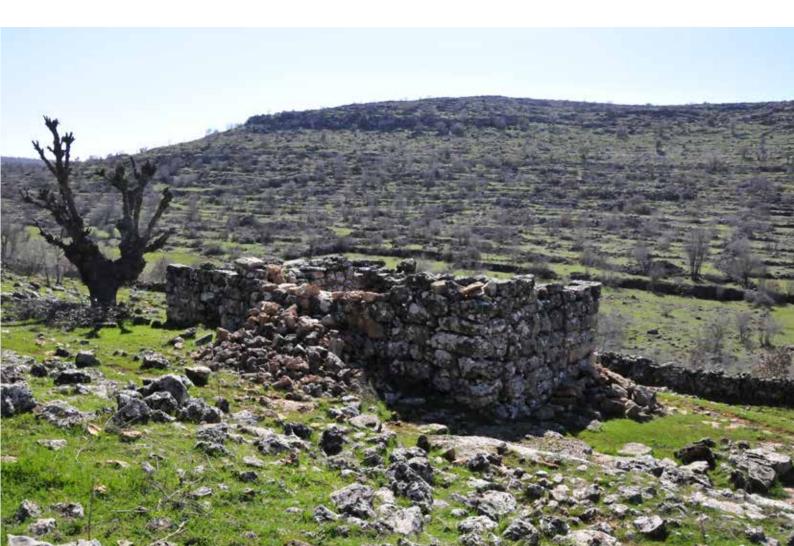
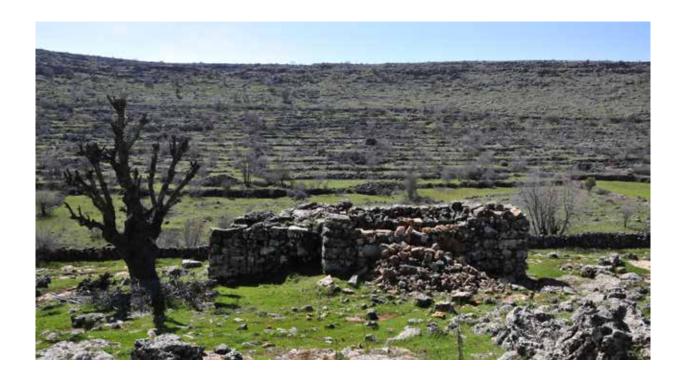
The apse is accessed through a door opening with a flat lintel in the east of naos. The apse

has a rectangular shape and there is an altar in the form of a rectangular niche in its east wall. A rectangular window, just above the altar, illuminates the interior. Although the upper structure of the apse is in ruins, the remaining wall coursing indicates that it was once covered by a vault.

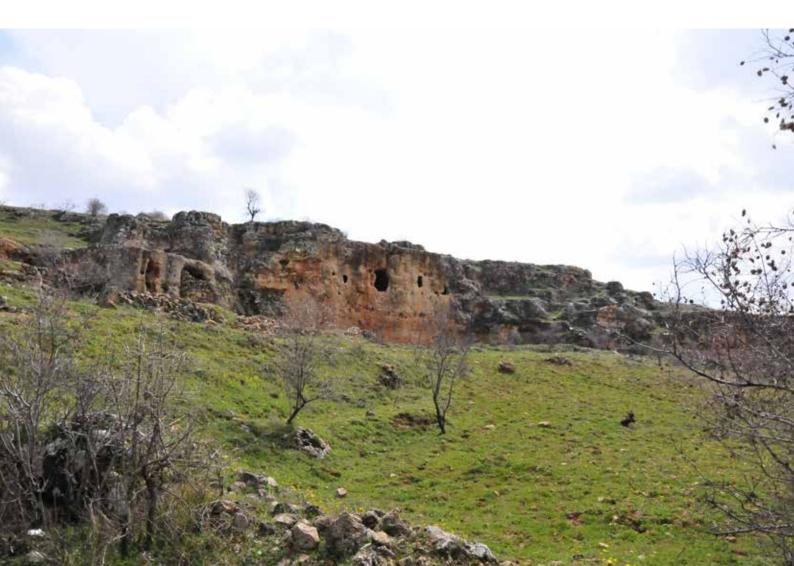
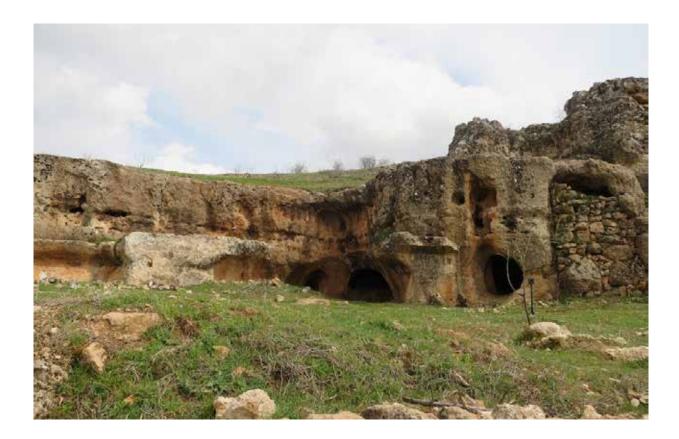
The entrance in the northwest of the upper floor leads to a corridor. This corridor is

connected to the spaces in the north of the entrance. The rectangular space with concave corners in the north of the entrance is reached by an L-shaped corridor. There are arches of different sizes with semi-circular profiles on the north, east and west sides of this space. To the north of the niche in the west is a window opening within a niche illuminating the interior.

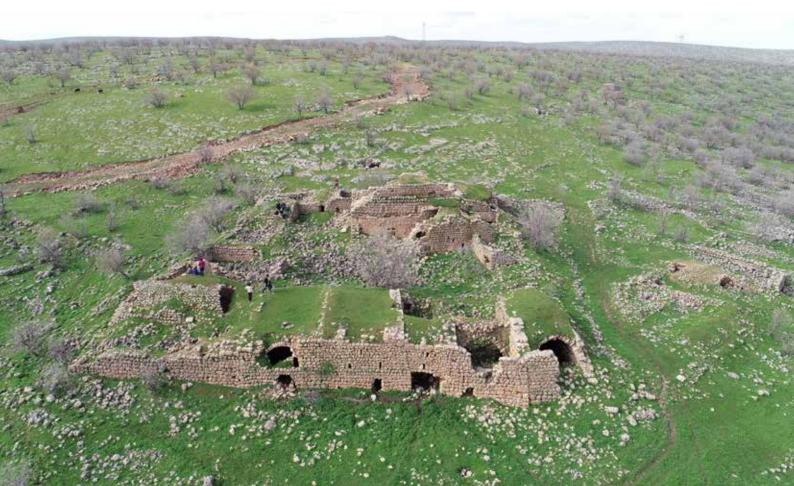
The church is within a monastery complex situated about 2 kilometers east of the village of Rowen (Karalar). There are many ruins in the area, especially to the west and the south of the complex, which may indicate that the monastery was possibly part of a settlement. The roughly square-shaped complex is surrounded by thick, fort-like walls. It

is built mainly of rough-cut stone; however, the arches and columns of the church are of fine-cut stone. There are many quadrangular units within this complex, which usually share walls. Most units use the main outer wall of the monastery as one of their walls. Although the roofs of most of the buildings have collapsed, the remaining ceilings are all vaulted. All of the collapsed vaulting and walls have fallen onto the ground below and have been further covered with soil and vegetation, preventing any study of the interior. From the remains and the levels, it can be inferred that there was a central courtyard in the complex. The only space that can be partially understood is the main church, which is rectangular on an east-west axis. There are also traces of a narthex to the south of the nave. This plan replicates typical parish type churches and is not common in monasteries of Tur 'Abdin.

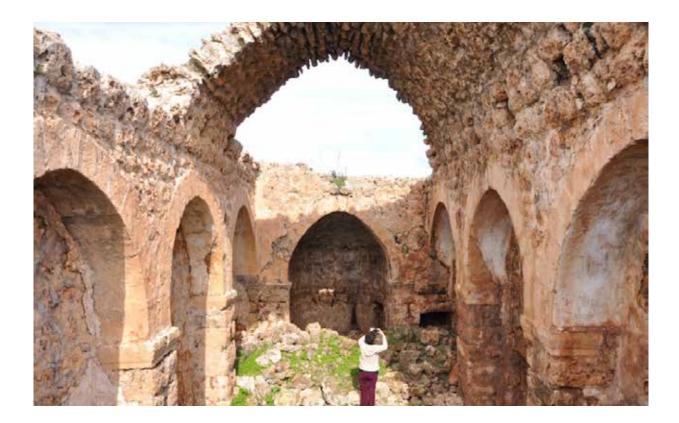
The monastery complex, located in close proximity to the village is in ruinous condition. The church of the complex preserves only a very small portion of its vault at the center of the nave. The flat-rubble-stone vault, today appears weakened from loss of binding material and is likely to further collapse in the future if no protective measure is taken. Similarly, only a small part of the semi-circular arch of the south aisle remains standing. Despite its condition and the fact that the original floor elevation is filled with a significant amount of earth and collapsed building material, the plan of the church is sufficiently legible.

The uncoursed random rubble masonry exhibits material loss due to weathering processes and has mostly lost its plaster rendering. Parts of the rendering are evident in the interior of the church at the north east corner and while other attached remains cover parts of the upper ashlar built elements (voussoirs) of the south and north arcades. The complex appears free of decorative elements incorporated in the masonry.

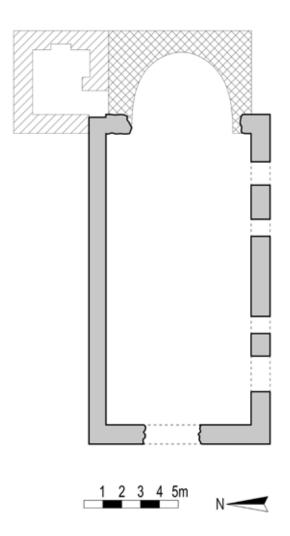
than gardens, and are probably of a fairly recent date. The drone was prevented from flying, as the site is in a no-fly zone because of proximity to the border. Air photographs would have been so useful; this absence is partly compensated for by good Google Earth imagery, especially one under snow in December 2013, although these cannot provide details of individual buildings.

The church is close to the centre of the settlement. The plan of the church is comprised of a rectangular nave with its long axis westeast and semicircular apse within a square end. The apse was narrower than the nave. A side chapel was accessed from the north-east corner of the church; its west wall abuts the north-east quoin of the nave, although it is largely a separate structure. Entrance to the church is towards the west end of the south wall. There are two windows in the south wall and a niche or another doorway low down towards the east end of the south wall.

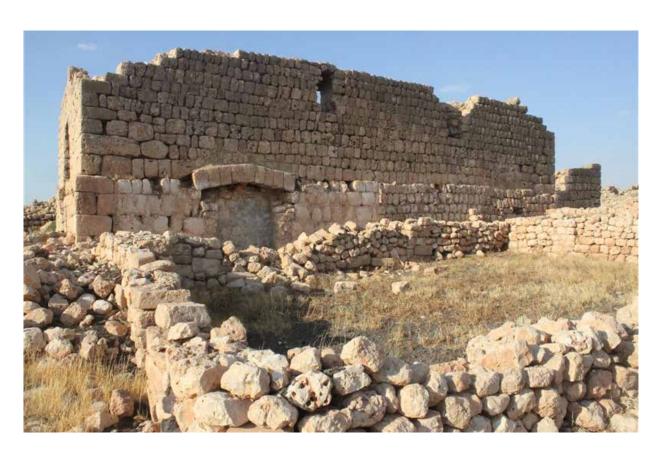
Little is now visible of the exterior of the apse. It can be seen that the east wall was aligned with the east wall of the side chapel. Also the south-east corner of the nave forms a clear quoin, inside and out, which means that the building narrowed at this point. The earliest visible fabric is the large ashlar blockwork at the south-west corner, west of the doorway. This is typical of the masonry of the early Tur Abdin churches, and so it is possible that this is a fragment surviving from a Late-Antique building. Everything else, with the possible exception of the blocks of the inner quoins of the apse arch, which are similarly large blocks, although now largely obscured by collapsed masonry, is rebuilt in less well-squared and smaller blockwork. This forms the majority of the exterior masonry, and represents the main build of the church, including the west elevation and the segmental arches over features in the nave. Elsewhere there are also further patches of still-later rebuilding, notably to the east of the south doorway.

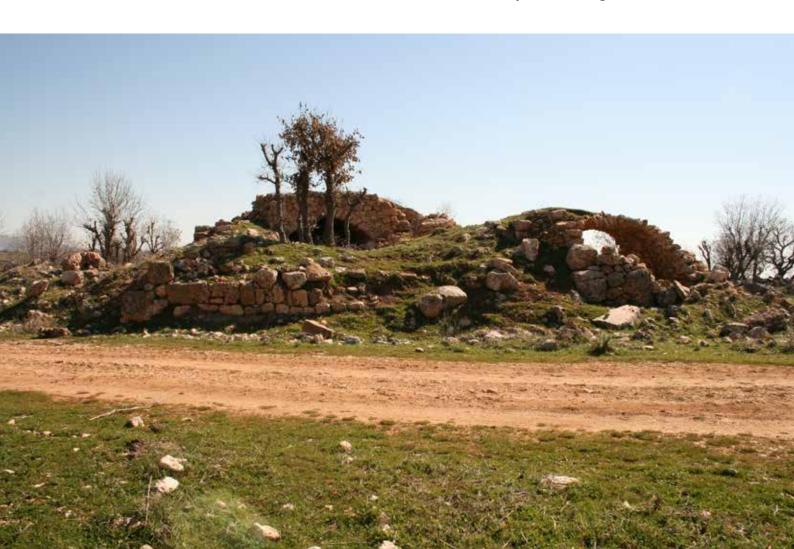
Two decorated stone blocks are identified in front of the eastern façade of the building. One of these blocks has an inscription panel written in Syriac Estrangelo. While the

inscription mentions the names of certain priests who were martyred, it does not indicate any date. The other stone block has a cross motif with equal arms.

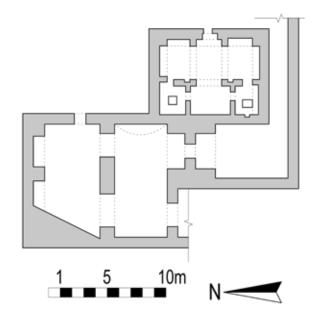
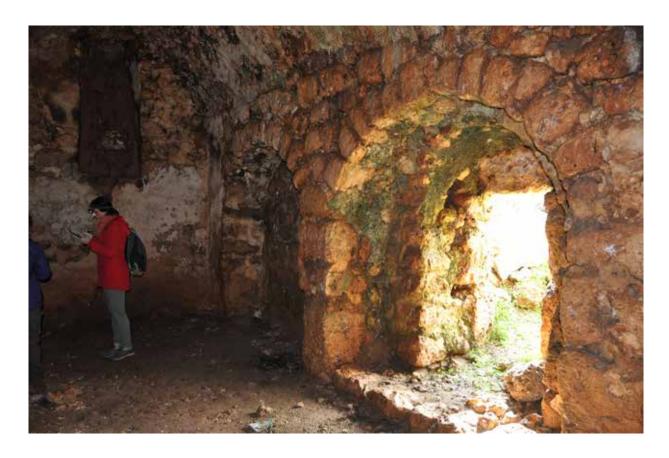
In the east, parallel to this entrance space is another room with the same length. This room is divided into three spaces. The apse's arch opposite the entrance was also filled, but it is seen that this infill wall had

later collapsed. There are altars in the side chambers in the north and south of the apse. There are passages from these rooms to the middle of the apse. To the north of these two rooms is a corridor with an entrance from the courtyard. This corridor leads to another room behind the apse. This room lies on an east-west axis and covered by a barrel vault. In the south of this room, and accessed by two arched openings. While all of the walls

of the monastery are attached to each other at almost a right angle, the eastern wall of this room extends diagonally on the northeast-southwest axis. Another passage is observed in the west of this room, but it cannot be reached due to debris.

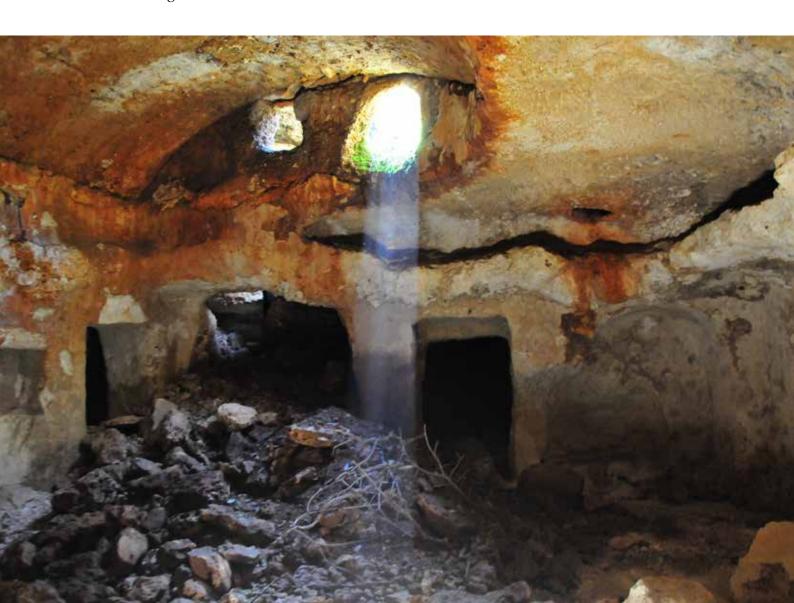
The building is completely underground and accessed through a void formed later in the bedrock in the south. From this

opening, a tunnel approximately three meters in width and twenty meters in length leads to a rock-cut rectangular space extending from the south-east opening of the church. This space is the greeting space of this building group, which is thought to be an underground monastery, and its entrance is marked by an arched niche. There are five arcosolia in the four walls of this space.

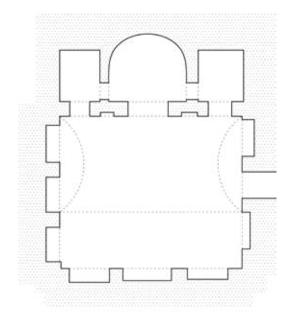
Plan of the main church of the monastery

1 2 3m

The monastery's church is a typical monastery type church. The naos has almost a square plan and the apse is tripartite. Since the church is carved into the bedrock, the eastern part of the naos is carried by a barrel vault constructed with rubble stone in a north-south direction underneath the bedrock.

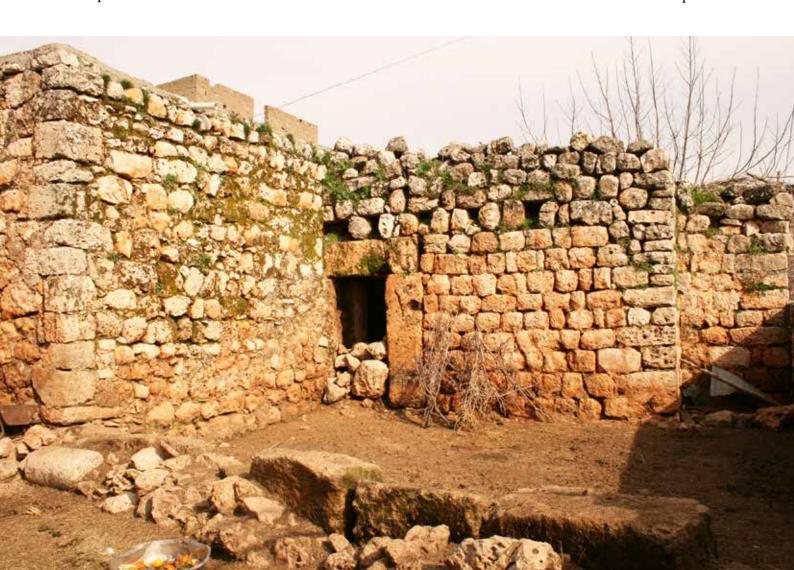
The entrance to the church is through an opening with a flat lintel in the middle of the south wall. The only light source is a small embrasure window, narrowing outwards, which coincides with the center of the apse

wall. To the east of the interior is a circular apse, framed by a rectangular wall from the exterior. The cut stones of the apse archivolt are larger than the other stones of the building. The imposts of the arches are carved from large horizontal rectangular stones in the form of simple column capitals. There are no ornamentations other than these imposts. The upper level of these imposts also coincides with the vault's springing line.

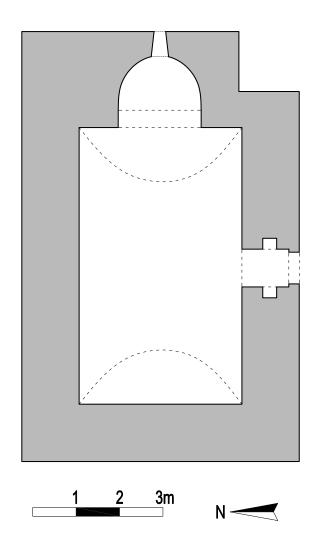
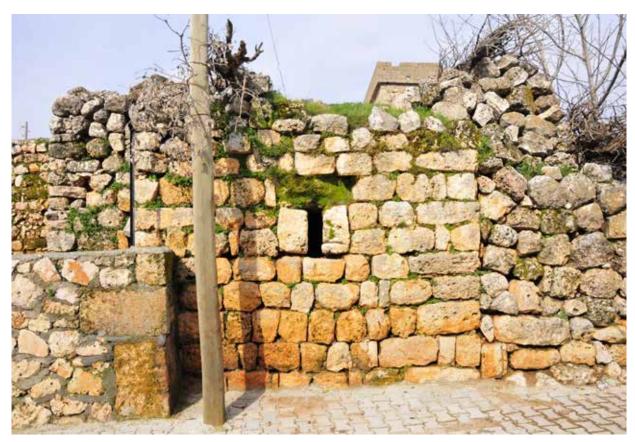
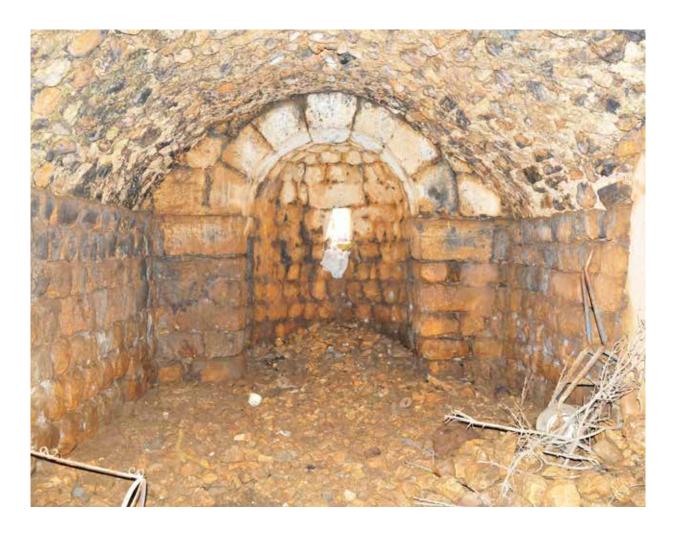
perceived as a single building. However, the church's plan and spatial characteristics are traceable.

There is no door in the entrance opening, which is closed arbitrarily with rubble and shrubs. Since the ground level of the church is covered with rubbles, garbage, and soil, it is not clear whether the original floor still exists. Structural cracks, material losses, water penetration, and surface weathering are observed in the church. Vegetation and algae growth are seen especially in the upper structure and at the upper levels of its façades due to water penetration. There are material losses at the eastern end of the upper structure. Salt deposits are observed on the walls due to water leakage as well as discoloration caused by soot indicating that fire burned within the building.

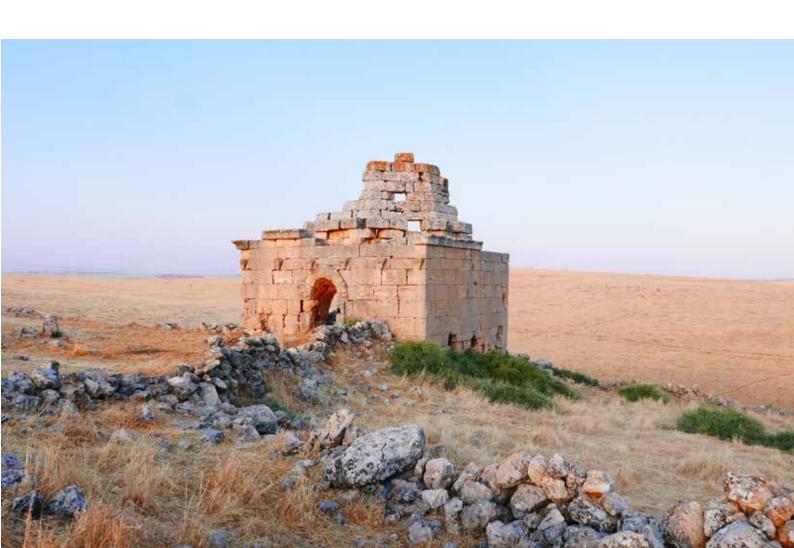
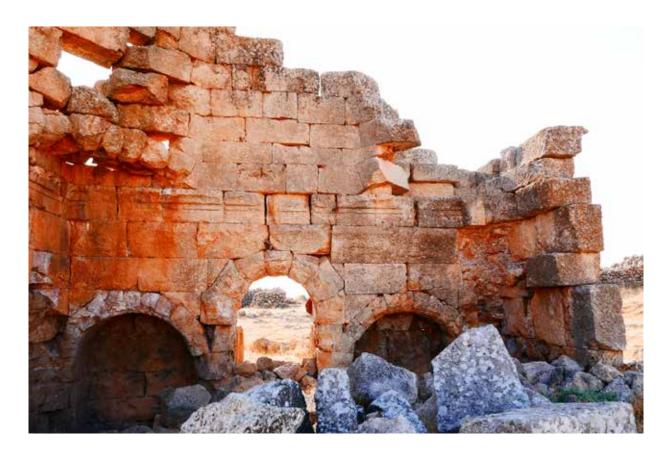
The eastern façade, where the entrance door is located, has a finer workmanship than the other façades. The door opening has a semi-circular arch and both the door jambs and the arch itself are articulated with profiled moldings. On the row of stone just

above the arch, there are five triangular decorations resembling column capitals, protruding from the façade. The other façades are comparatively plain. A molding runs along all four façades, at the upper level of the main walls.

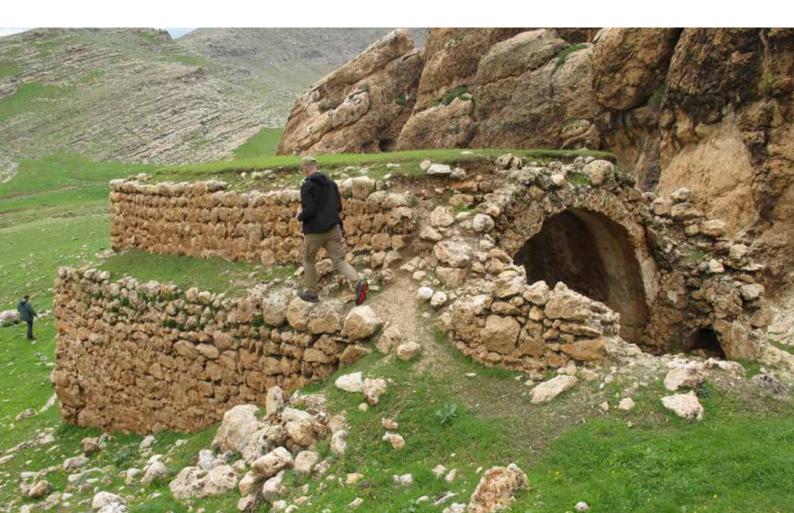
out to form a small plain, now cultivated as fields. The rubbly area to the west of the church could represent the limit of an entrance court; but it could equally be one of the field retaining walls typical of this area. Features cut into the rock at the base of the cliffs to the north, include a cistern.

The plan is rectangular externally, accommodating a rectangular nave with apsidal sanctuary internally. The north and south walls have two niches. The apse is separated from the nave by a high wall, with a gap in the centre providing an entrance to the sanctuary. There are smaller niches on the north and south sides of the curve of the apse, with arched heads and plastered interior surfaces.

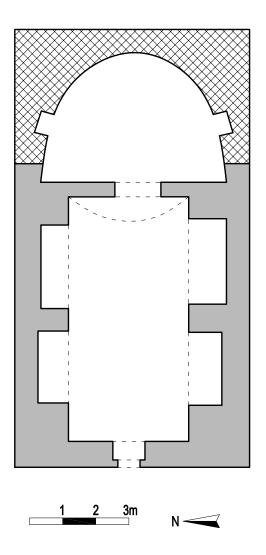
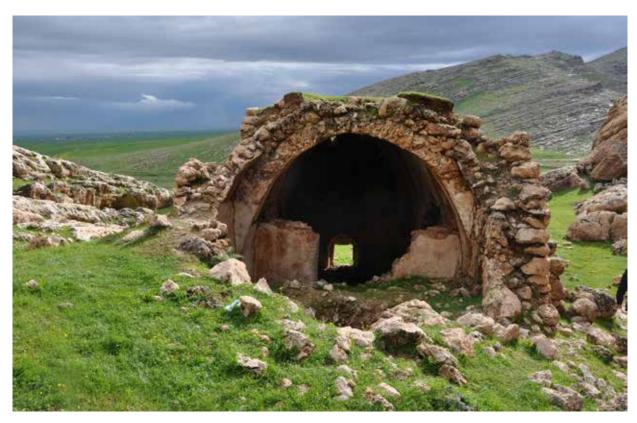
The church is mainly of roughly-squared limestone rubble masonry. Semi-squared and rather larger blocks are reserved for corners and architectural features such as door frames and *abaci* blocks of the piers. There are also occasional blocks of better-squared stone among the rubble, possibly re-used from an earlier structure. Arches and vault ribs are constructed of unshaped, or semi-shaped voussoir blocks. The nave retains its vault, consisting of a rubble barrel vault,

abutting an arched rib of better-formed voussoirs on the archivolt of the apse. The exterior wall surfaces are partly rendered. The areas lacking this treatment perhaps represent rebuilds. Interior wall surfaces are lime plastered, with some areas fallen away.

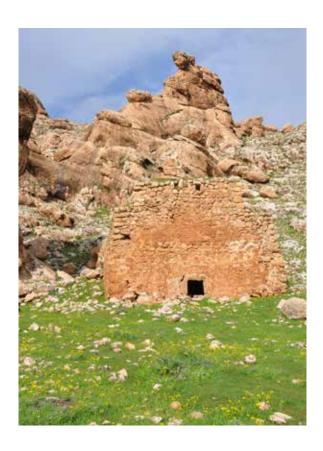
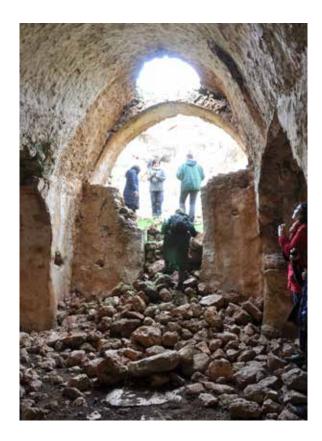
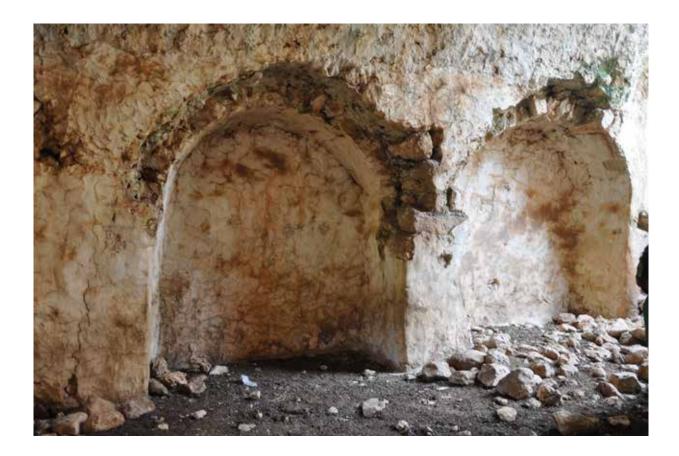
The east end of the nave is limited by a wall up to the level of the springing of the arch with a central doorway retaining its plastered reveals. The curved wall of the apse has a rubble masonry skin facing up a cut in the bedrock (striated earth layers are visible in section where a segment of the apse

wall has fallen away), with an internal plaster face. There are niches north and south; the wall is missing at the eastern limit, so it is unclear whether there was another niche there. The interior is filled with collapsed rubble and debris to its full surviving depth.
